Warranty conditions

The following cases deal with a number of cases of handling the Patent Joint Chisel while cutting out cement joints. The examples indicate what is and what is not possible and the consequences.

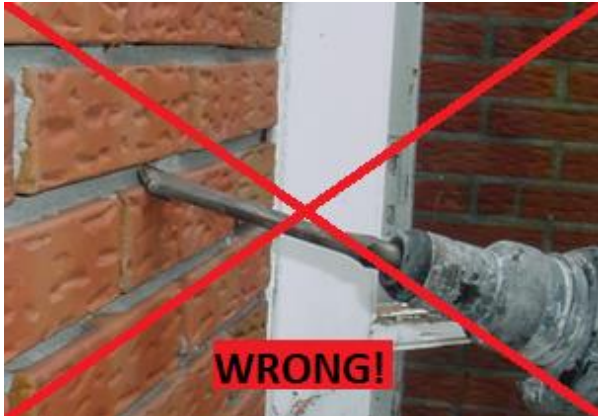
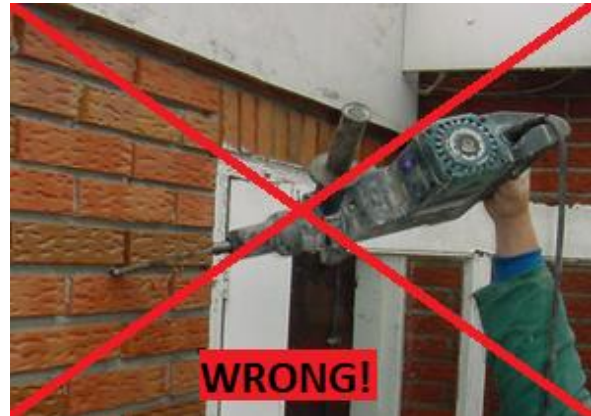
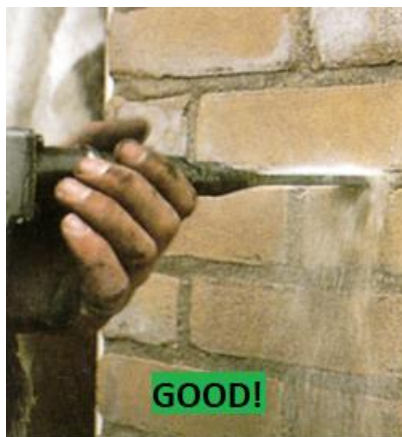
1. The “lean fracture”

This break is caused by the chisel is being held up or down at an angle when the joint is being cut out. This creates extremely high mechanical forces on the chisel blade at the location of the teeth and the middle area of the chisel blade. Due to the movement of the machine (number of strokes per minute) and the simultaneous uneven walking along the façade of the hacker, these tensions can rise to such a high level which ultimately leads to breakage of the chisel blade. The teeth can also be weakened in such a way that this can lead to accelerated fracture as discussed in point 3 of this leaflet. Never tilt the chisel in the joint! Judgment: NO leniency/guarantee.

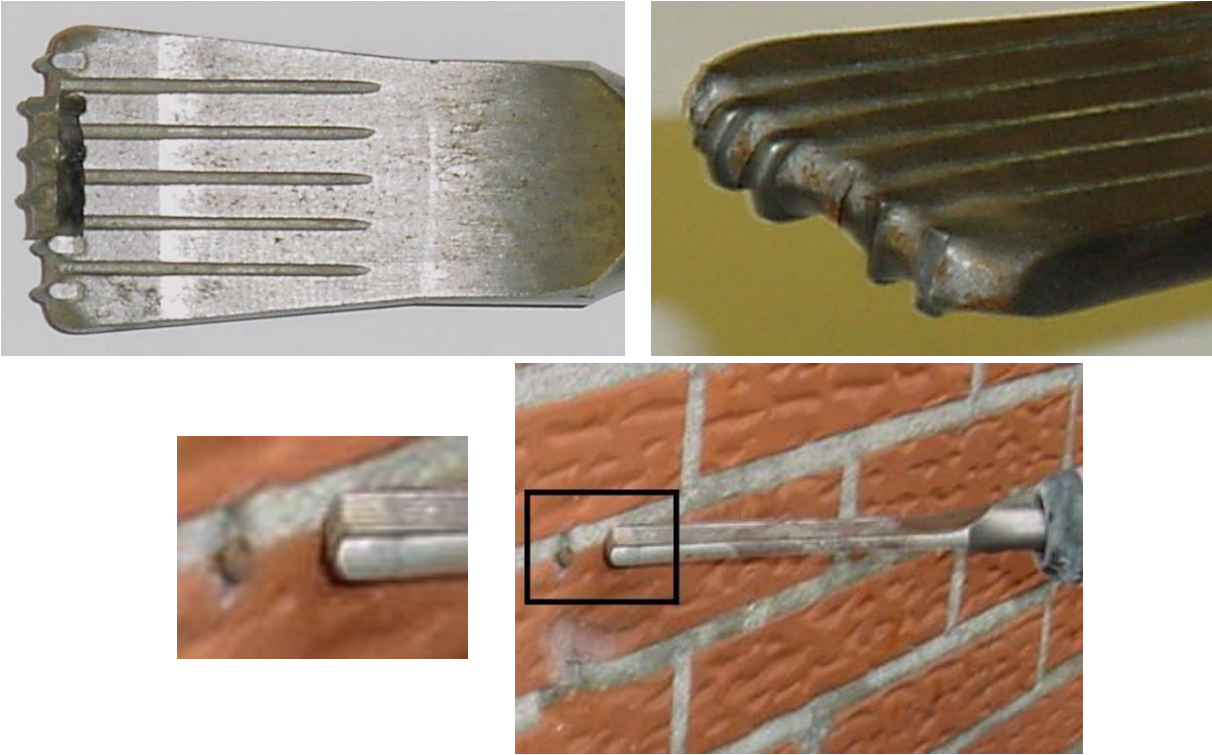
3. The “tooth fracture”

Tooth fracture or the breaking of the tool tip can be caused by nails or screws in the joint, a wall anchor or a larger pebble in the cement. This allows a tooth to break off and/or break out a complete piece between the teeth. One of the reasons for this can be as described in point 1 of this brochure. Judgment: depending on the use and wear of the chisel, a leniency may or may not be given (after the result of the examination/evaluation of the manufacturer).

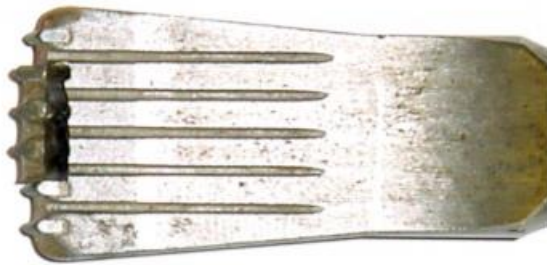
C.)

Picture C also shows a chisel with “torn teeth”. In this case also apply the same rules as above. Reimbursement only takes place when you directly stopped chopping and by timely sending the Patent Joint Chisel to us.

In some cases it could be possible that there was no optimal bonding between the soldering process of the teeth and the chisel metal. Through the mechanical vibration of the chipping hammer (machine) the teeth then spontaneously fall out of the chisel. If you find this problem, you should immediately stop chopping and remove the chisel so that more damage to the chisel is prevented. When the chisel looks like as the chisel showed in picture A, the chisel can still be repaired and we will replace a new carbide tooth for free.

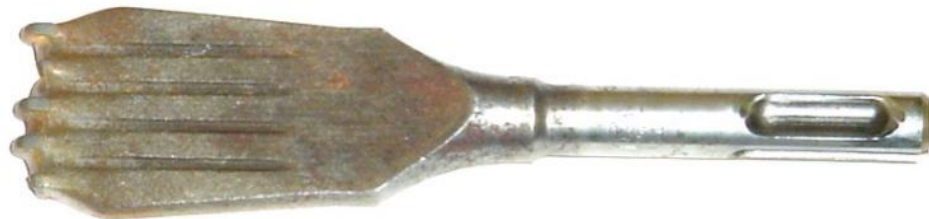
Excessive wear

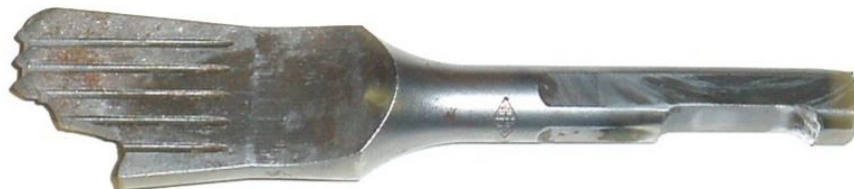
Chisel blade fracture
due to impact against
hard object in the façade

In all cases of damaged chisels, please contact us first before returning the chisel!
